## SAFETY NOTICE

Regarding Roth Solar Panel, type Heliostar 252/252 S4 and 218/218 S4 manufactured in the period from 01/2008 until 05/2011 and sold in a period until 05/2012.

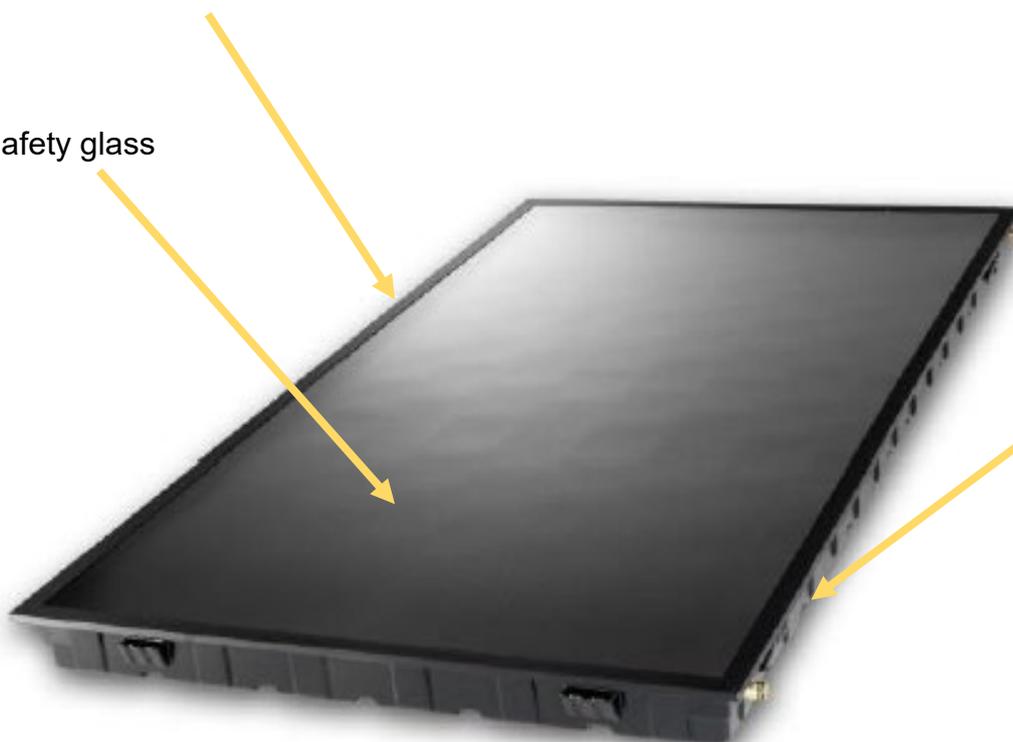
The Roth Heliostar solar panel consists of a plastic tub with a “sun catcher” inside and a glued on solar cell glass made of hardened safety glass. An aluminum frame made out of 4 glass cladding lists are glued all around the plastic tub to protect the panel from water and other external factors.

Aluminum frame

Safety glass

Plastic tub

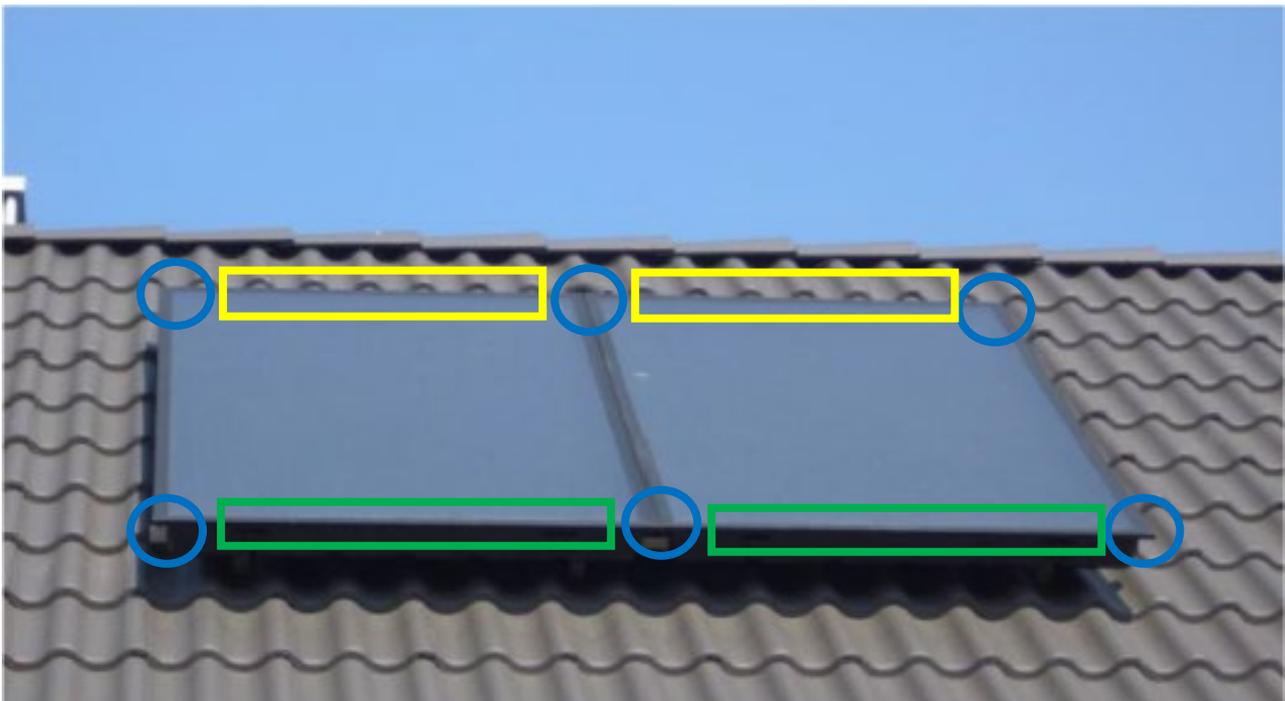
The areas to be checked are the following:

- The corners/miter cuts (blue marking)
- The bottom aluminum frame (green marking)
- The top part of the solar panel (yellow marking)

As mentioned we recommend that a visual inspection of the panels be conducted to check for any of the structural changes described on the following pages 4, 5 and 6.

If the panels are accessible/viewable from the ground using binoculars, a camera with zoom etc., and the changes described on pages 4, 5 and 6 are not identified then no further action is required.

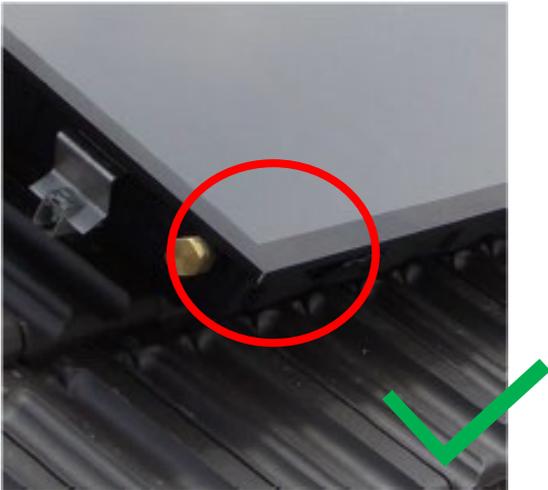
Picture 1

An early indication that further action in terms of remediation could be required is that the corner joints of the aluminum frame has opened (For reference see pictures 3 and 4)

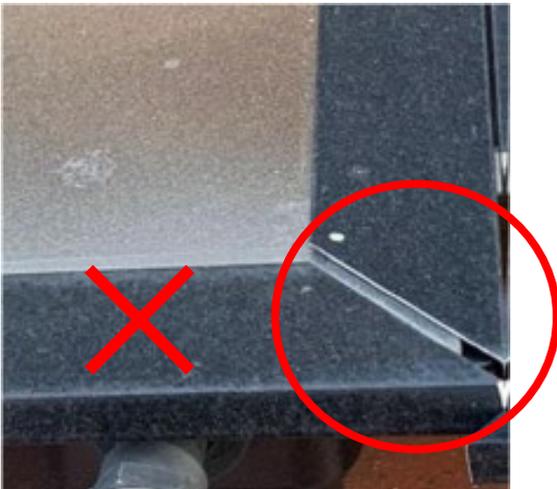
Picture 3

This could, if not detected in due time, lead to the glass on the panel coming loose, with the risk of the glass sliding of the panel. (see pictures 3, 4, 5 and 6). As far as we can tell these changes happens very slowly, and by conducting a service check on a regular basis, the changes will be visible long before any critical flaw or failure occurs.

We would recommend that inspections are conducted and that action is taken accordingly if structural changes to the aluminum frame is found (see pages 4, 5 and 6)

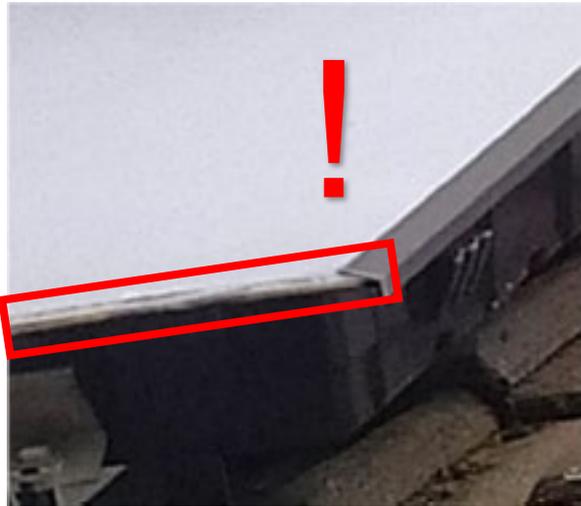
Picture 5

The bottom part of the aluminum frame has come loose or has already fallen off. If the aluminum frame falls off, it will rarely fall to the ground but will instead, due to its geometry and low weight, end up in the gutter or stay on the roof structure. This will make it hard to detect as the frame will not be on the ground, but the changes can easily be seen through optic devices. (For reference see pictures 5 and 6)

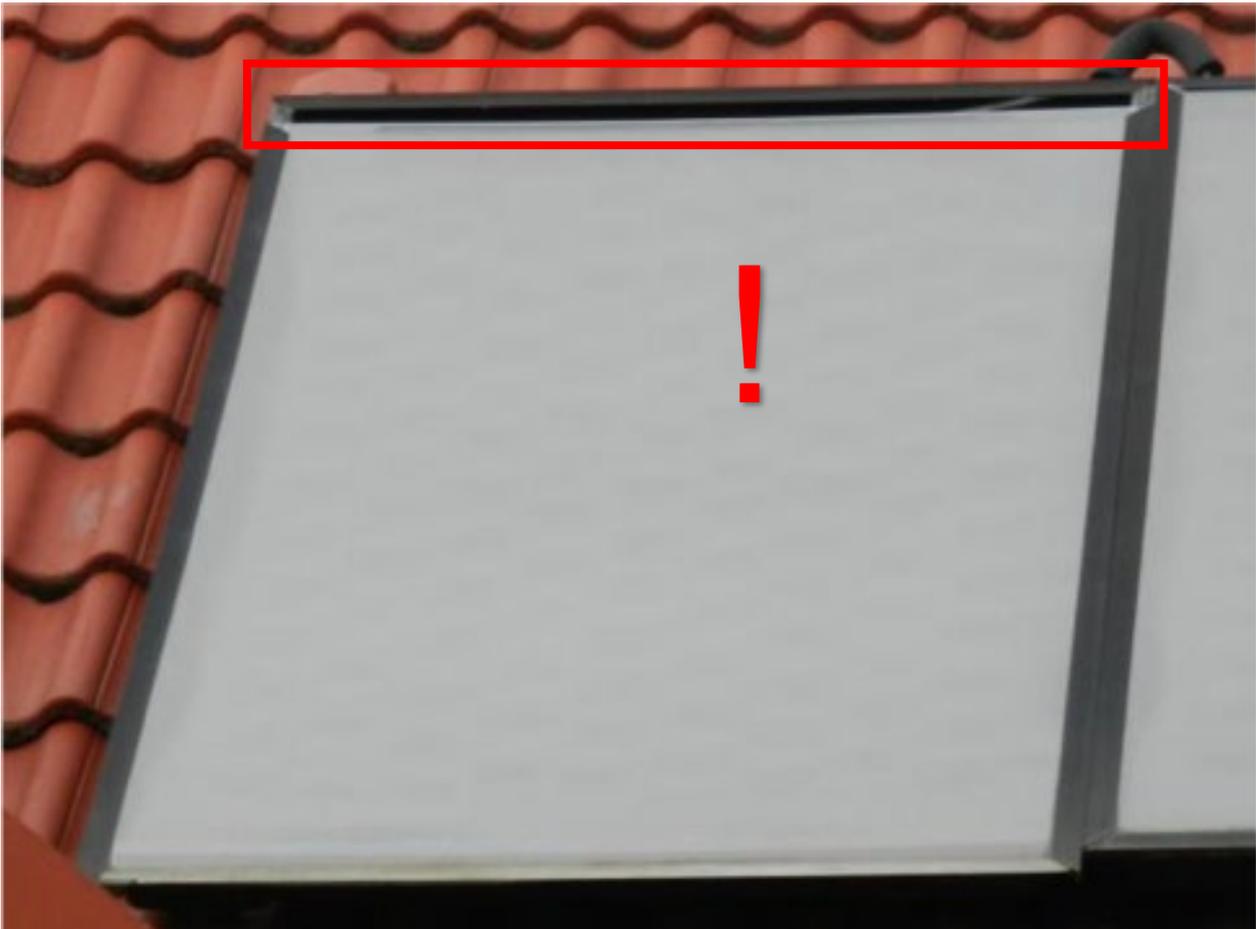
Picture 7

The clearest indication on a possible flaw on the solar panel is that the glass has slid down making a visible hole/crack on the top part of the solar panel. (For reference see picture 7)

If changes on the solar panel consistent with picture 7 are detected the solar panel must be taken out of operation and secured safely until remediation has been performed.
